Horning Geosciences

November 4, 2020

RE: Geologic Hazard Investigation for roads, including Loukas Lane/Lewis & Clark Mainline and Fort Clatsop Road/Lewis & Clark Road, including the old Crown Zellerbach sorting yard, from the sorting yard south to the intersection of the Mainline with Wadsworth Road.

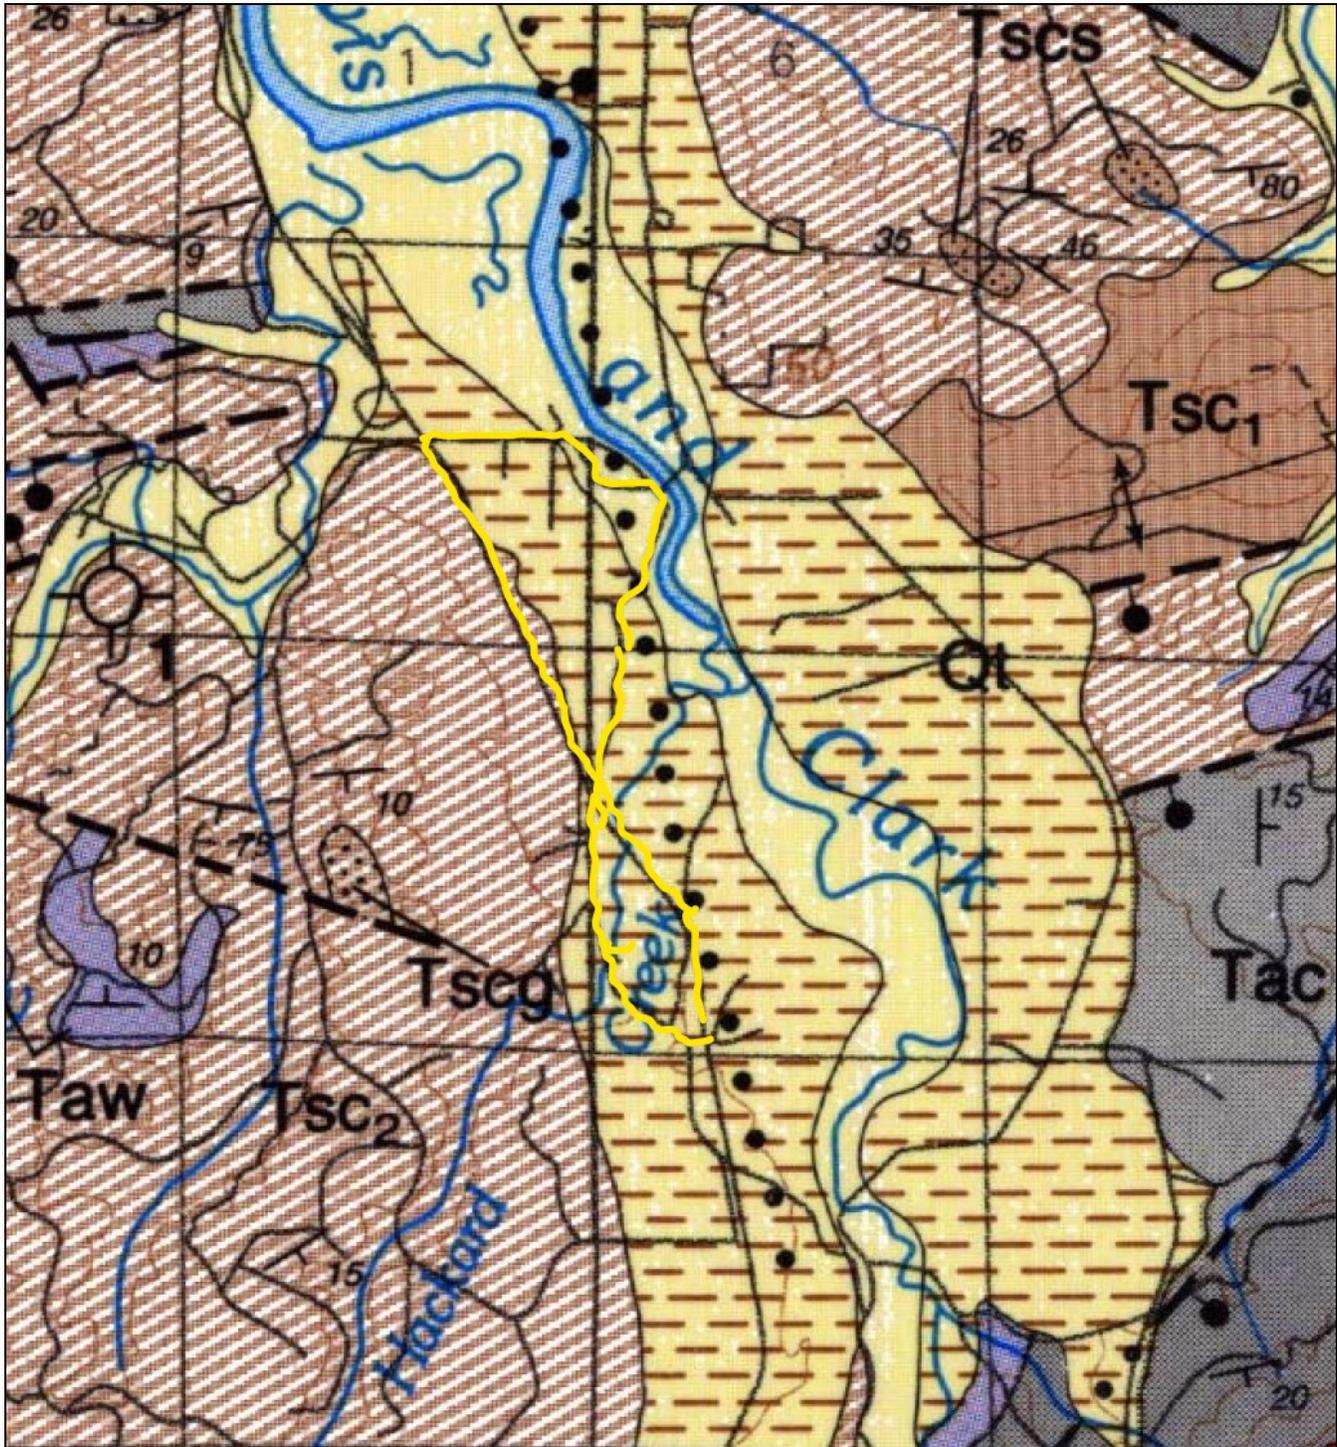
Figure 3: Geologic map for the project area; after Niem and Niem (1985). Most the roadways lie on uplifted Pleistocene river terraces (Qt; buff with dashed pattern) or younger modern flood plain (buff without dash pattern). A concealed, but inferred, fault runs NNW beneath the valley, as indicated by heavy dark dots. The terrace sediments lap onto and partly bury Oligocene Smugglers Cove tuffaceous siltstone (Tsc2). Roads inspected are highlighted in Yellow.

A concealed fault runs north-northwest beneath the valley. It offsets Smugglers Cove siltstone on the west from Miocene mudstone of the Astoria Formation on the east. Likely, the west side of the valley has risen differentially against the east side. Regional fault models suggest that this part of the county is actively involved in a clockwise rotation that involves both vertical uplift and horizontal strike-slope movement. The terrace sediments have been elevated above sea level at a rate of about 0.5 to 1.0 ft per 1000 years. This rate averages out the effects of slow chronic uplift interspersed with abrupt subsidence events of as much as 6 ft during regional earthquakes. It is possible that subsidence can be as little as 1 ft.

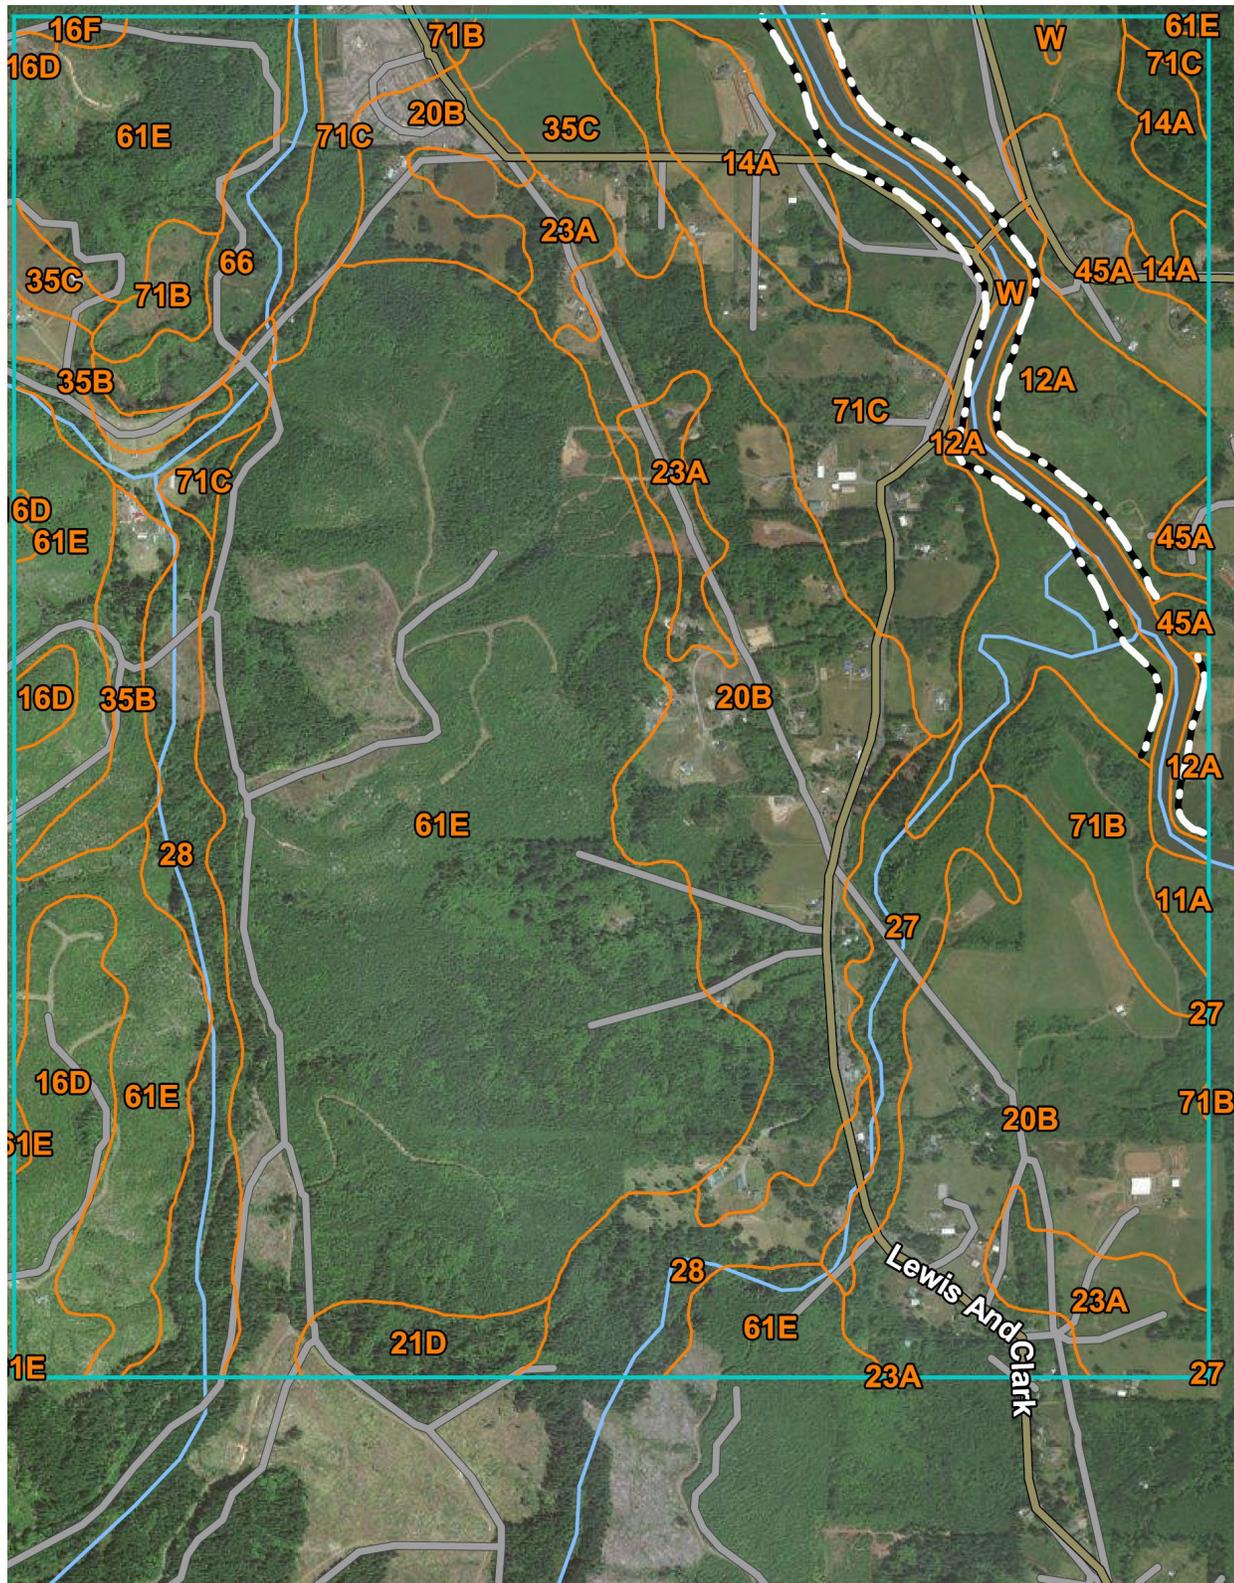
Figure 4: Soil map for the study area. Primary soils for this study consist of silty clay soils of the Walluski (71B), Grindbrook (21B), and Hebo (23A) soils. All form on terraces. Hebo soils tend to be saturated during winter and pose a small liquefaction risk. Coquille-Clatsop complex (12A) is modern swamp that is tidally influenced and composed of peat and clay.

Minor liquefaction hazard is present about midway between Heckard Creek and the sorting yard. Visual examination of saturation and LIDAR stream rill formation suggest that liquefaction is restricted to two isolated sites of about 100 ft each. The soils map suggests that saturation may be a hazard for as much as 1600 ft (Hebo silty clay loam- 23A). The absence of coarser clastic materials, such as sand and gravel, suggests that liquefaction is not very significant, as silt has a difficult time of expelling water and over-pressuring the ground, which weakens the soil, compared with sand and gravel. The presence of shallow groundwater is indicated, in part, by a private manufactured lake on the east side of the road.

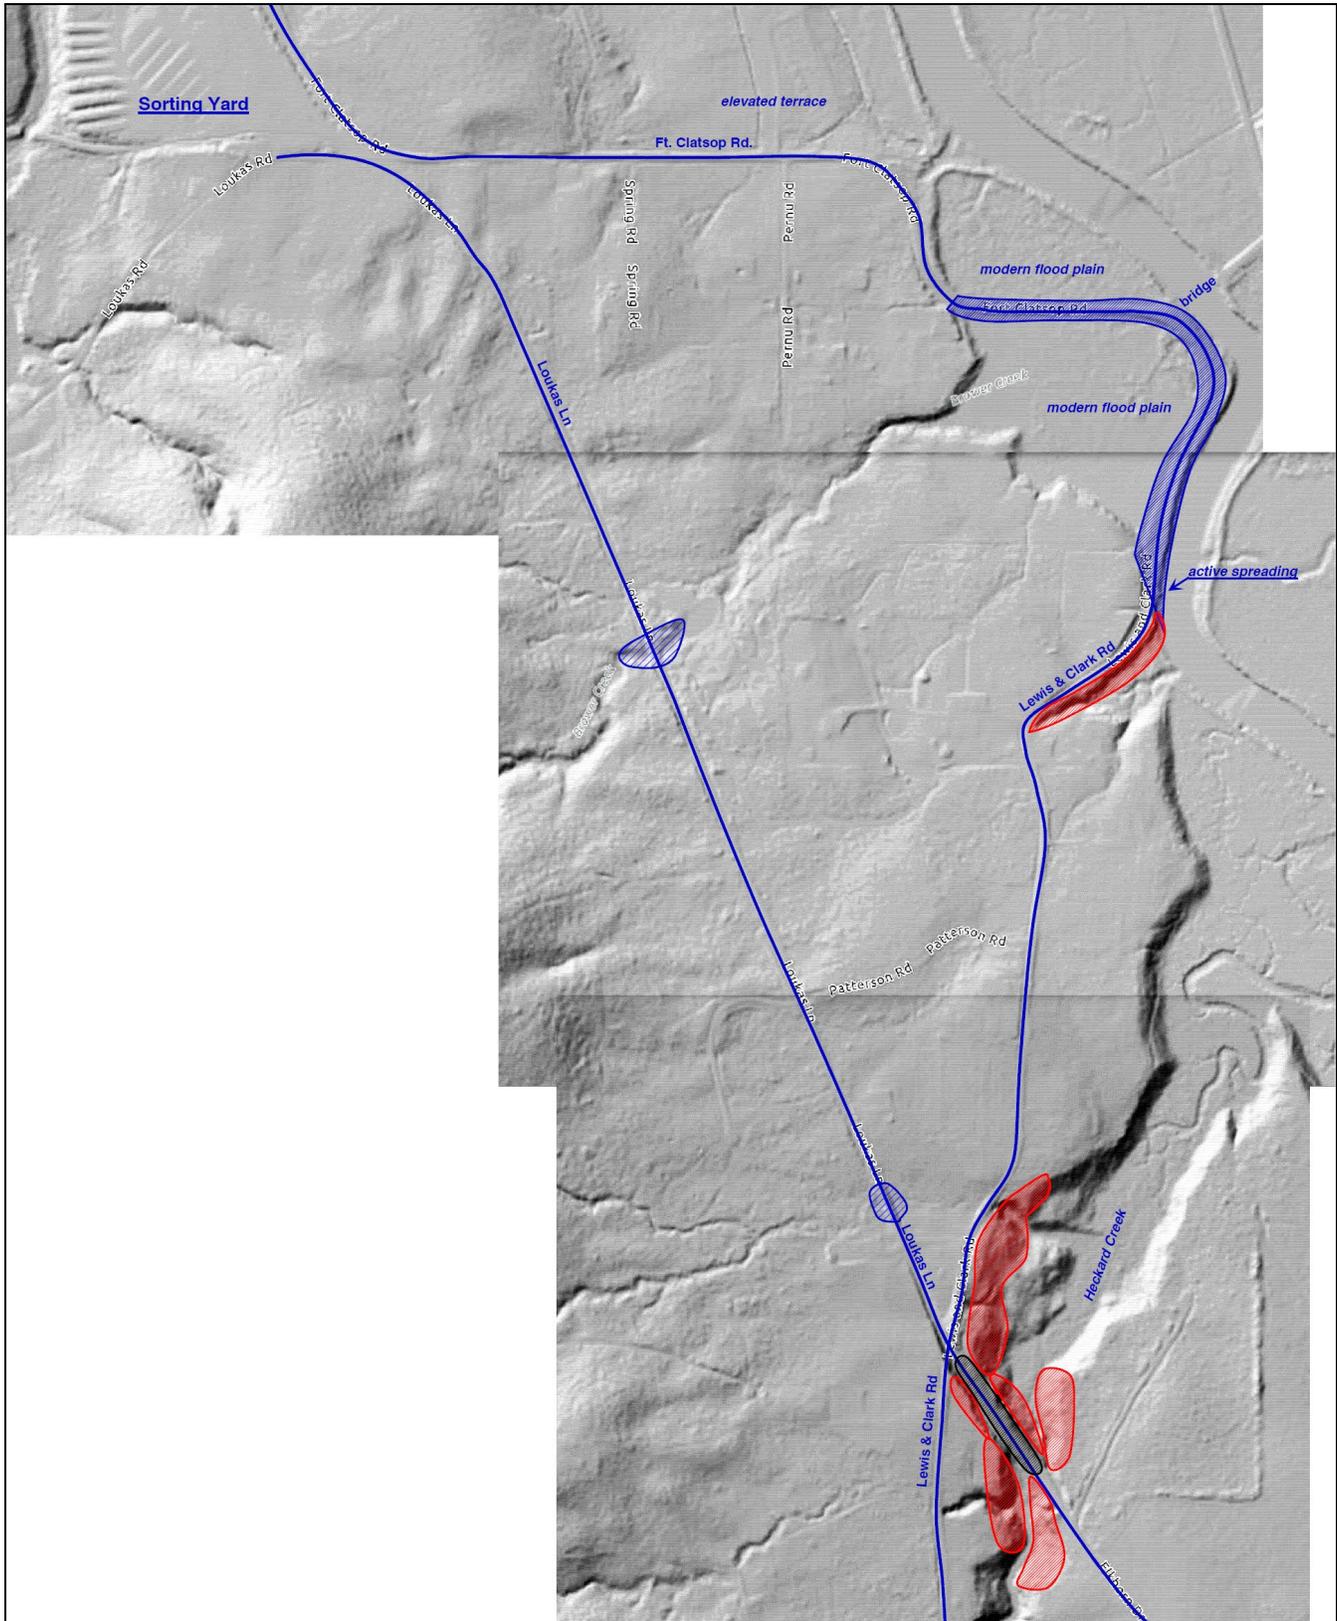
Figure 5: Northern part of the study area. Roads are highlighted in blue and overlain onto LIDAR-based shaded relief maps. Areas prone to slumping during a regional earthquake or from heavy saturation are highlighted by Red hatching. Areas subject to liquefaction and lateral spreading are highlighted by Blue hatching. Areas of structural fill at risk of failure are highlighted in Black hatching. Base maps are courtesy of the DOGAMI LIDAR viewer website. North is up. The elevated terrace is free of landslide landforms, except where incised by creek gullies or river banks. The absence of hummocky landslide landforms is strong evidence that future landslides will not occur.

Lewis & Clark/Fort Clatsop Road is exposed to landslide hazard and serious liquefaction/lateral spreading risk near rivers. The liquefaction hazard is confined to the dike road for 2000 ft in the northeast part of the study area, where the dike was placed to restrict the effects of tidal flooding. The road is experiencing lateral spreading and rifting asphalt where the dike road laps onto the steep embankment above the modern marsh. Future spreading is likely during shaking. The susceptible area on the edge of the terrace runs for about 300 ft.

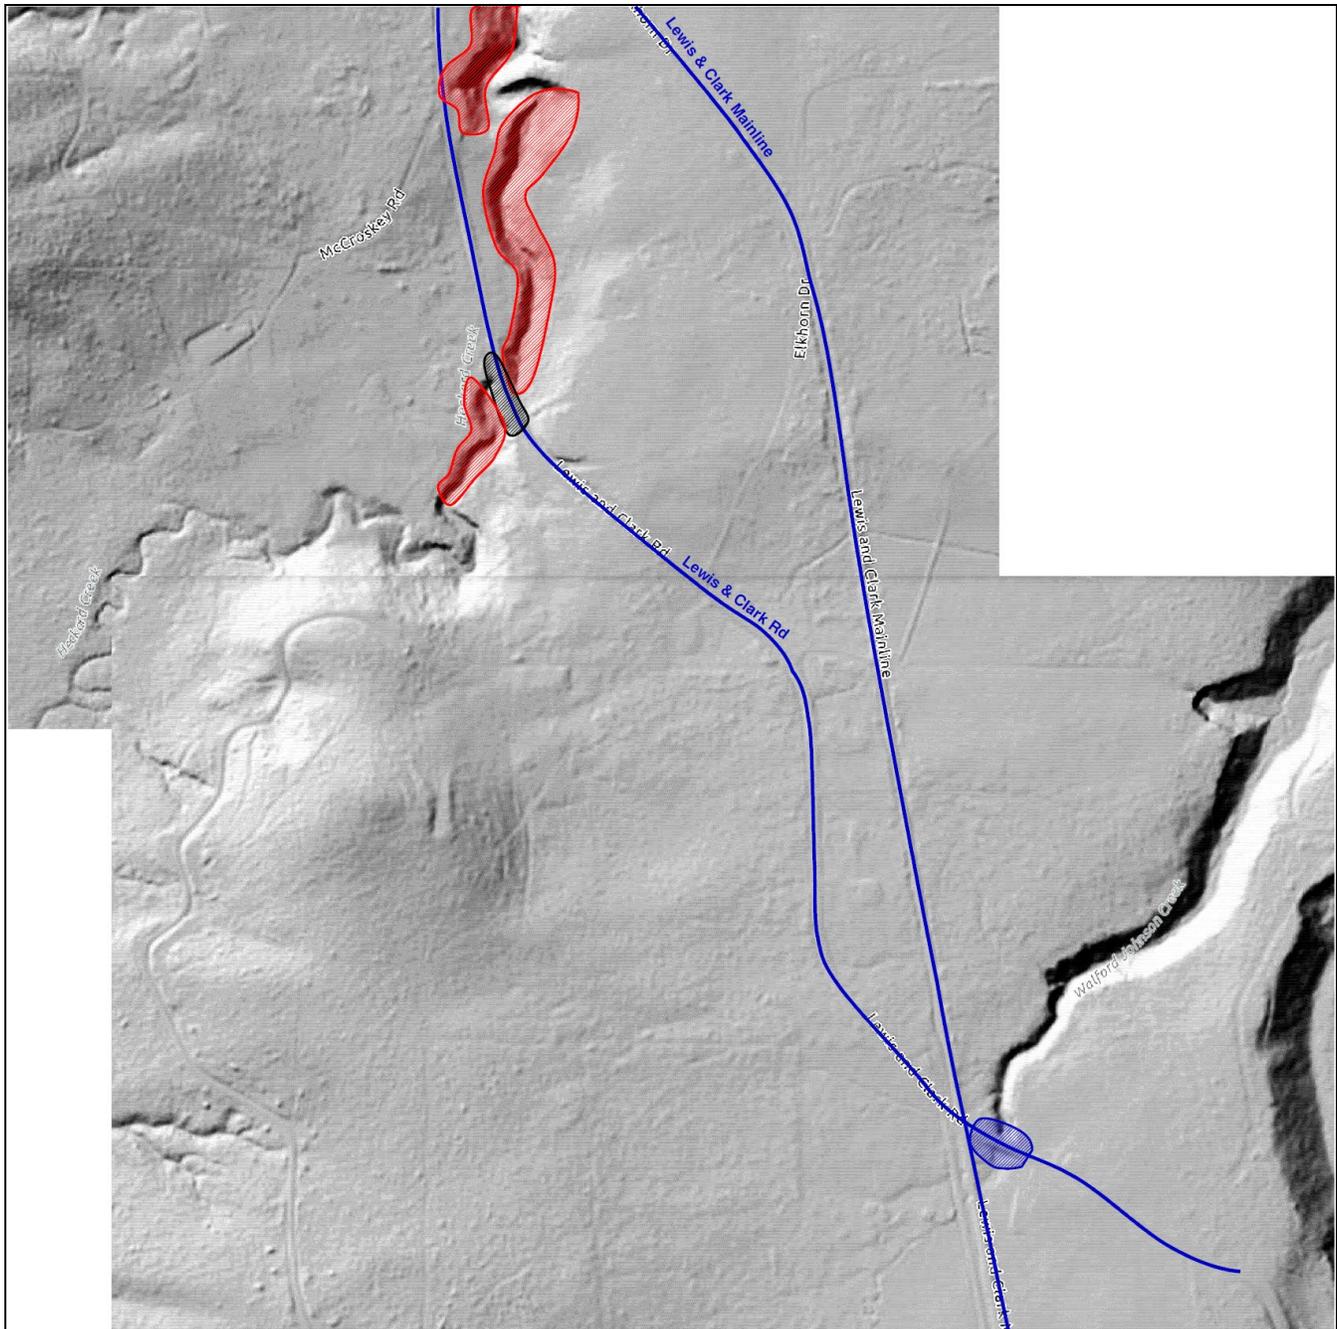
Figure 6: Southern part of the study area. Roads are highlighted in blue and overlain onto LIDAR-based shaded relief maps. Areas prone to slumping during a regional earthquake or from heavy saturation are highlighted by Red hatching. Areas subject to liquefaction and lateral spreading are highlighted by Blue hatching. Areas of structural fill at risk of failure are highlighted in Black hatching. Base maps are courtesy of the DOGAMI LIDAR viewer website. North is up. The elevated terrace is free of landslide landforms, except where incised by creek gullies or river banks. The absence of hummocky landslide landforms is strong evidence that future landslides will not occur.

The Lewis & Clark Mainline/Loukas Lane is largely free of landslide hazards, except for possible failure of the filled causeway that crosses the Heckard Creek gully. The causeway is about 360 to 500 ft long and is about 50 ft high above the gully bottom at the greatest. That it has not failed in the past significantly is testimony to its good design and construction. Further work on its stability is required. Nearby steep gully slopes pose cut-bank failure hazard, particularly on the northwest side of the gully where slopes can be as steep as 100 percent.

Farther to the south, bank failure below Lewis & Clark Road is a hazard near the Heckard Creek causeway. It affects about 1200 ft of roadway.

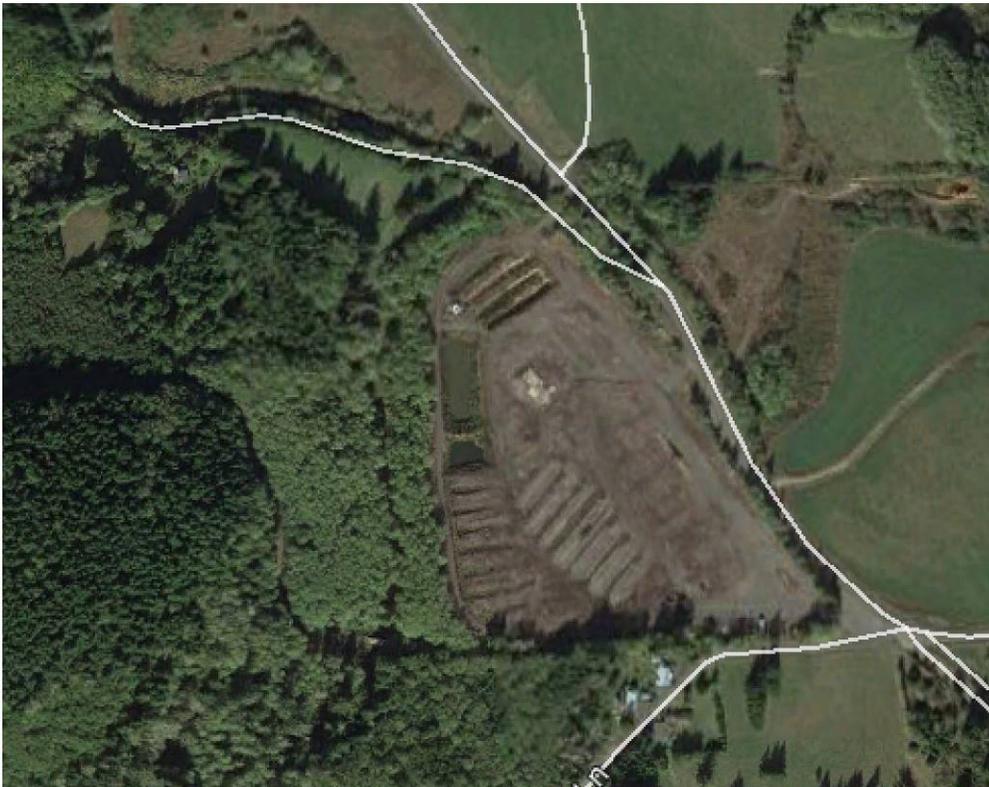
Figure 7: Sorting yard aerial photo showing ponds that presumably were for washing logs. Most likely they are filled with loose sediment and organic wastes. The edge of the sorting yard drops about 28 ft over a horizontal distance of 145 ft for an average slope of 19 percent.

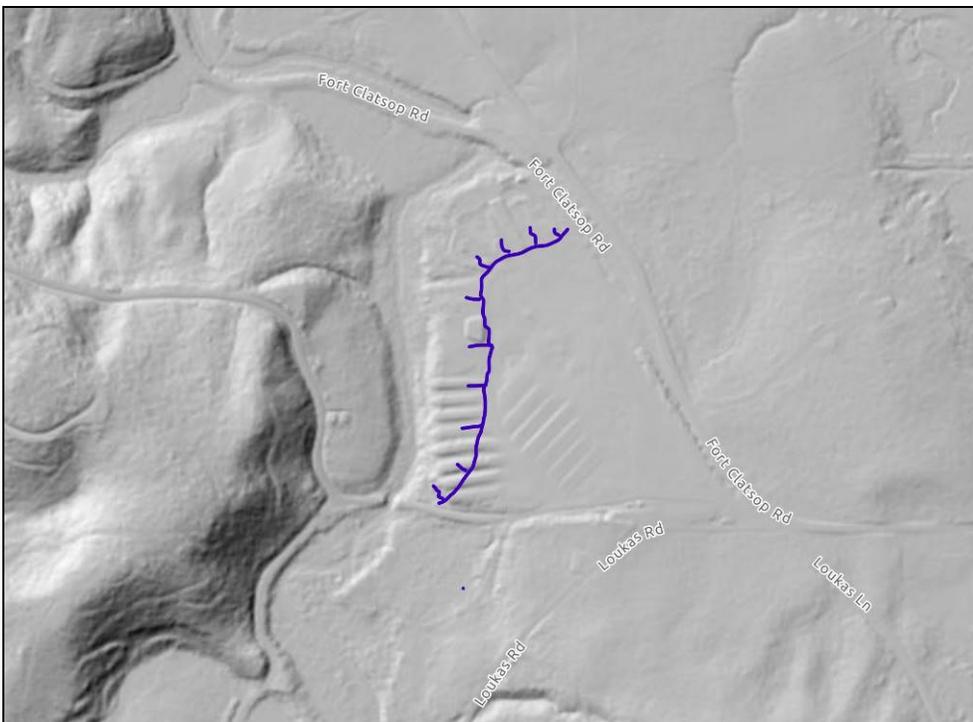
Figure 8: The blue toothed line delineates the edge of the settling ponds and weak fill that could spread during an earthquake. Compare with Figure 7.

The sorting yard is built on ground that presently slopes to the northwest at 4 to 6 percent. It appears that the yard rests on ground that slopes much like the field to its east, on the opposite side of the road, which is free of landslide landforms. Examination of the asphalt and concrete sorting bins finds no evidence of damage from recent or ongoing slope instability and landslide movement. However, a review of aerial photos going back to 1994 shows that the west and north sides of the yard have been progressively filled to construct ponds that presumably have been used to wash logs. It constitutes ground that is saturated and filled with assumed weak materials. The calculated slope for the west side, which drops down into the Johnson Creek drainage, averages about 20 percent over a horizontal distance of about 145 ft. Until it can be verified how it was built, it should be regarded as at risk of lateral spreading and should be avoided. A rough setback line is shown in Figure 8.
